October 29, 2020

Andrew Barnsdale  
Project Manager  
California Public Utilities Commission  
505 Van Ness Avenue  
San Francisco, CA 94102

**Re: Monthly Report Summary #35 for the South Orange County Reliability Enhancement (SOCRE) Project**

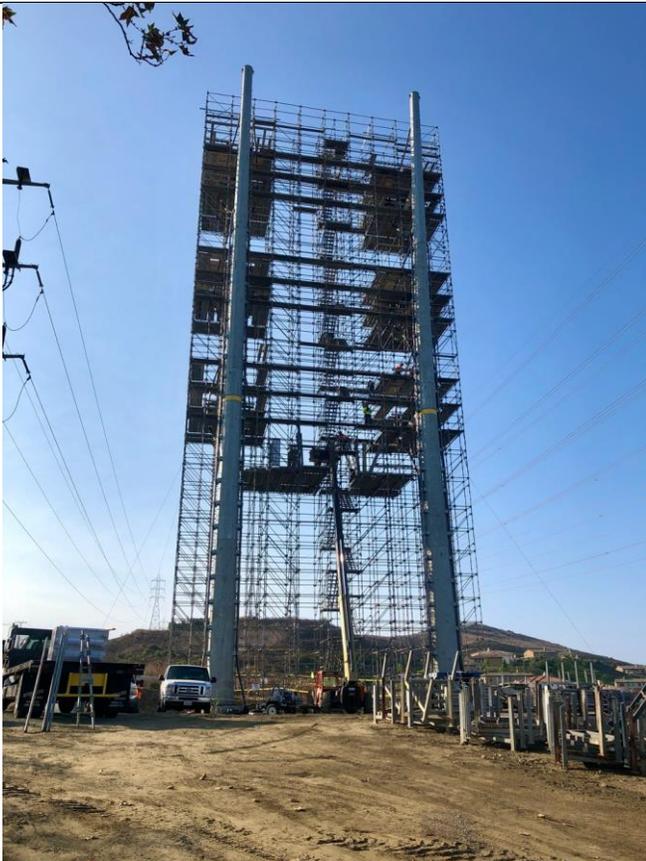
Photo 4 – Tower locations 18 and 19 with the scaffolding being installed. Photo facing south.
09/18/20	SOCRE transmission corridor

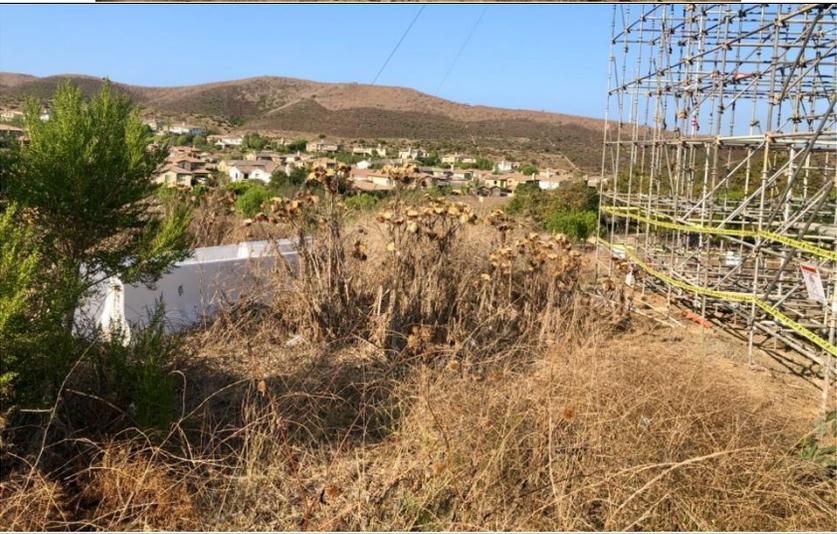
Photo 5 – The anchoring K rails placed in the vegetation at tower locations 18 and 19. Photo facing west.

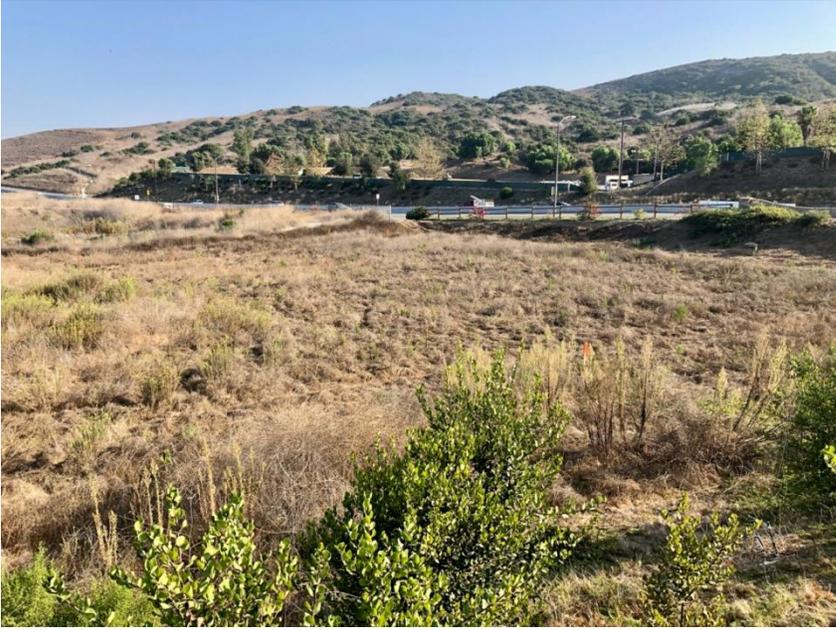
Photo 6 – Proposed helicopter landing pad located north of towers 18 and 19. Photo facing northeast.
09/18/20	SOCRE transmission corridor

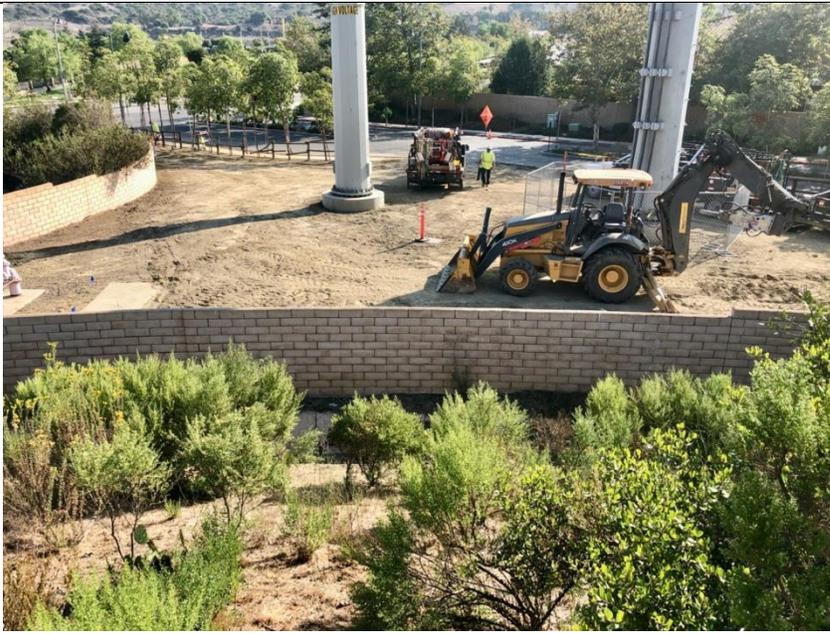
Photo 8 – The K rail anchor locations at tower locations 16 and 17. Photo facing east.
09/18/20	SOCRE transmission corridor

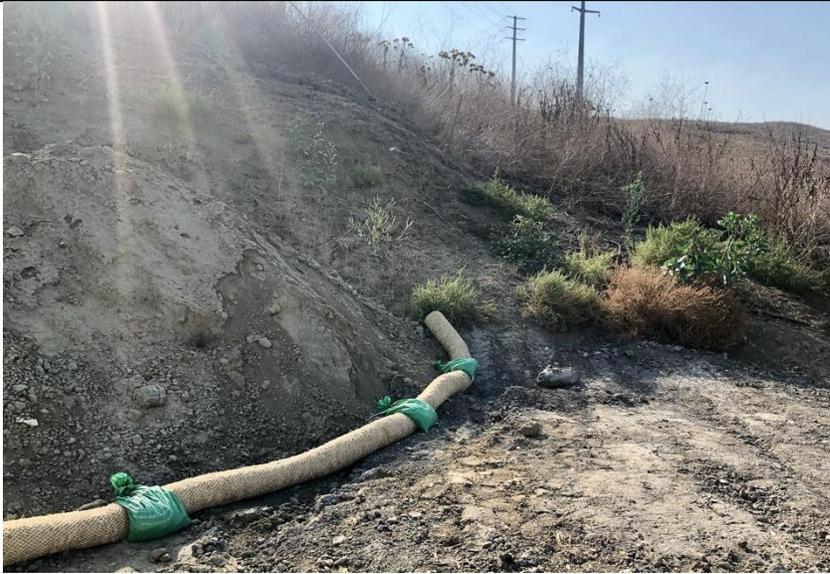
Photo 9 – Additional workspace needed near tower location 14 for crane activity. Photo facing south.

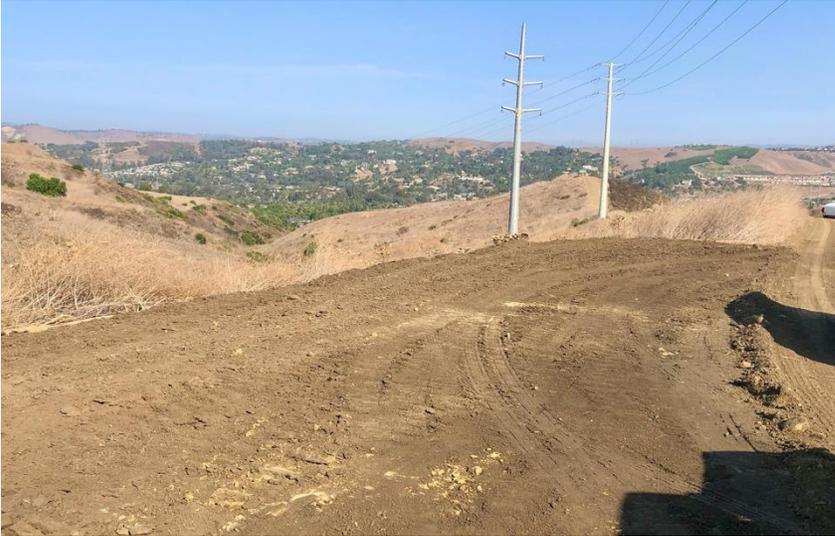
Photo 10 – Line pulling location along the access road near tower location 15. Photo facing north.
09/18/20	SOCRE transmission corridor

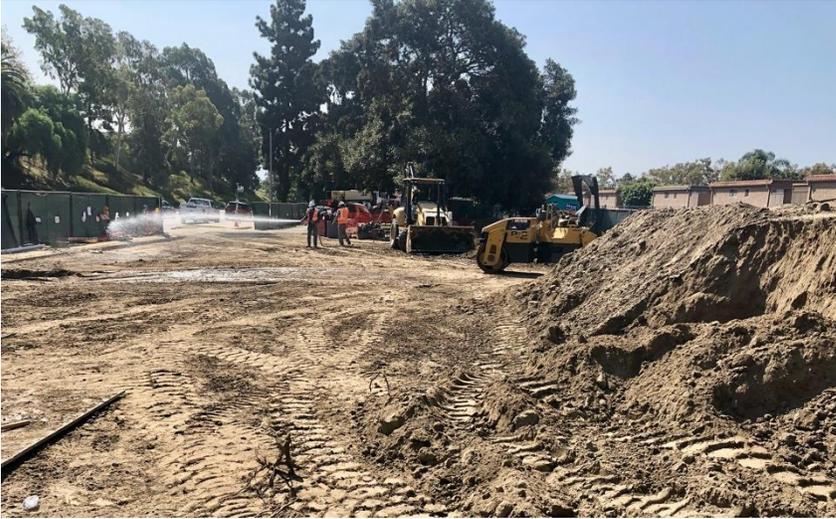
Photo 13 – Jack and bore site. Photo facing south.
09/18/20	West of San Juan Capistrano Substation-jack and bore site

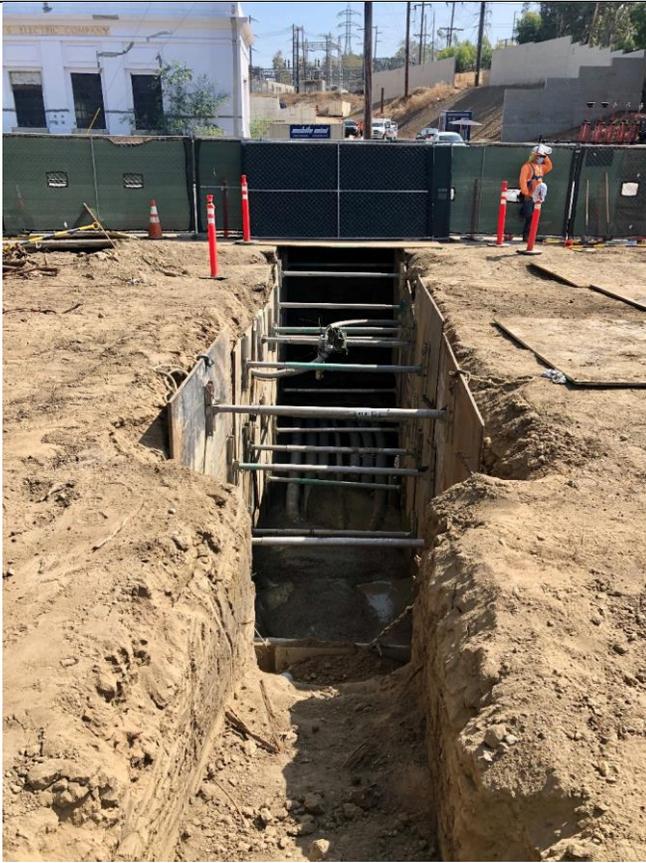
Photo 14 – Open trench within the jack and bore location. Photo facing east.

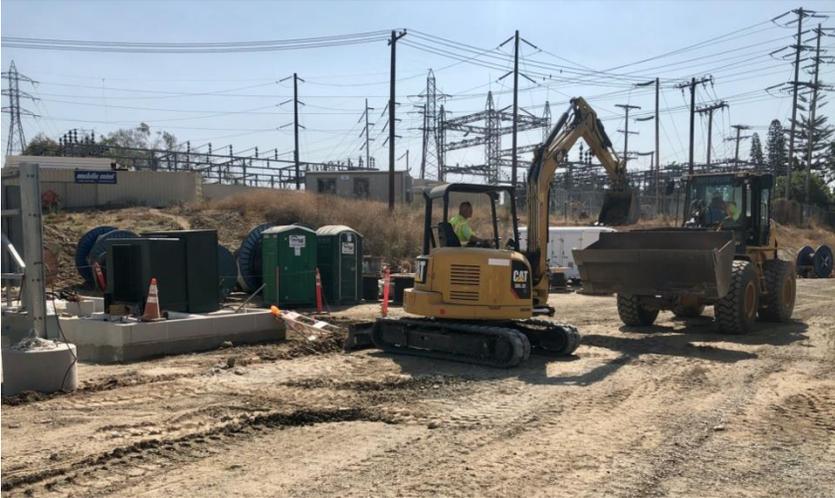
Photo 15 – Soil work underway within the substation. Photo facing southeast.
09/18/20	Serra Park east of the San Juan Capistrano Substation

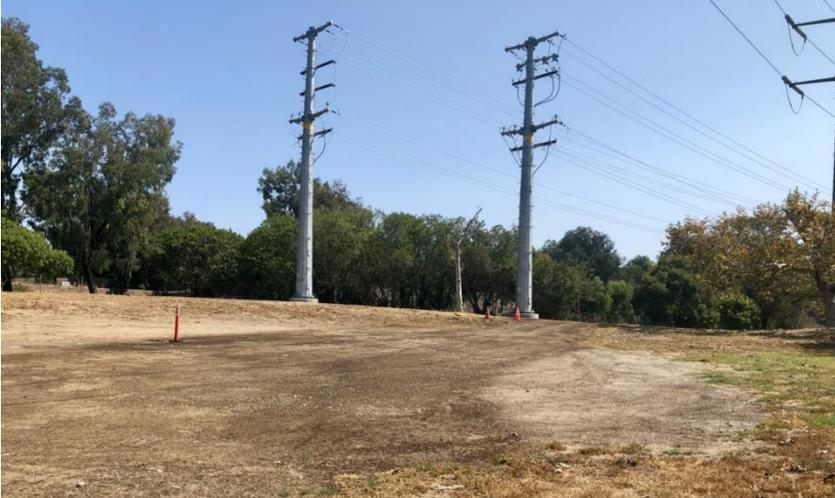
Photo 16 – The area of Serra Park where the temporary staging area had been cleaned up and reopened to the public. Photo facing east.
09/18/20	Serra Park east of the San Juan Capistrano Substation

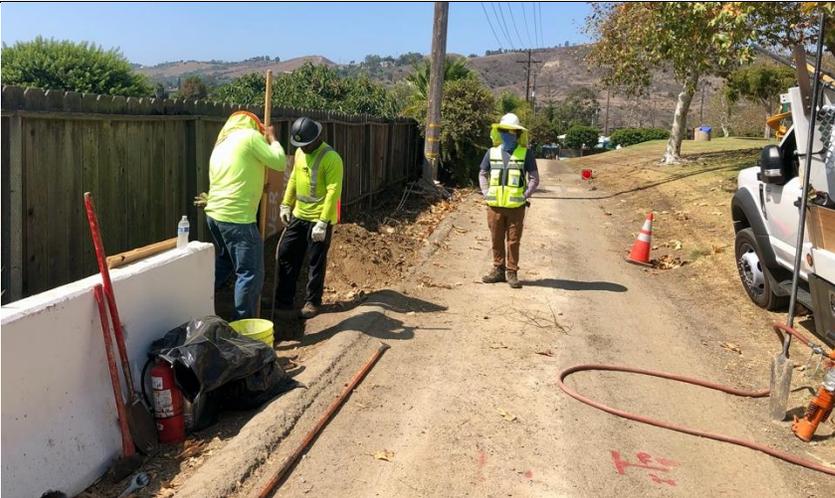
Photo 17 – Paleontology monitor observing excavation of 9-foot-deep anchor hole for pole in preparation for stringing new wire. Photo facing west.

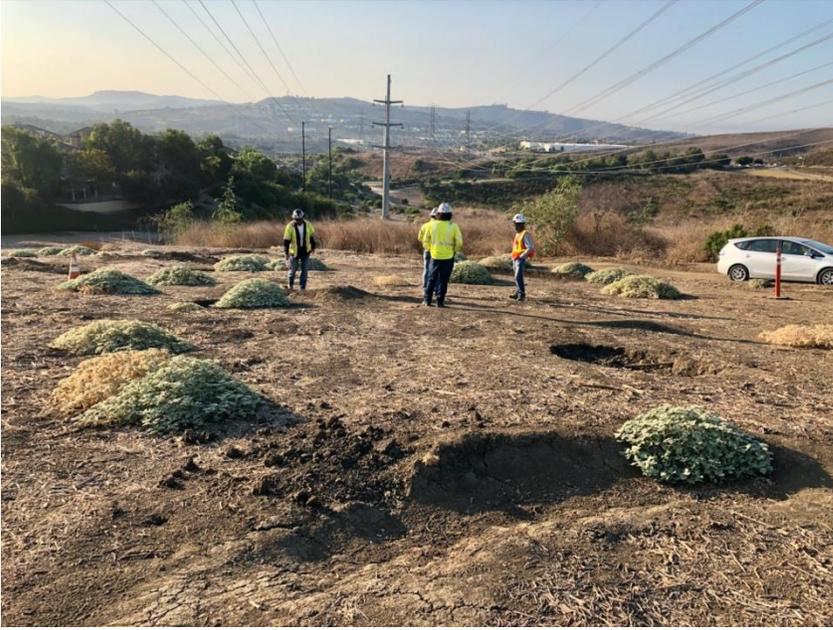
The EI and I met at tower location 30 to inspect the wire pulling site. The wire pulling site was located within the nearby access road. This site would not be suitable for work for the wire stringing as it runs perpendicular to the transmission line and would not be long enough. Another site was proposed located on the slope south of the tower site; this location was nearly devoid of vegetation and would require only a small amount of grading (Photo 1). It is preferred to use the new location as the wire pulling site due to the minimal impacts to biological resources. A biological monitor is scheduled to inspect the site and oversee the grading.

Photo 1 – Possible wire pulling site near tower location 30. Photo facing south.
09/24/20	SOCRE transmission corridor

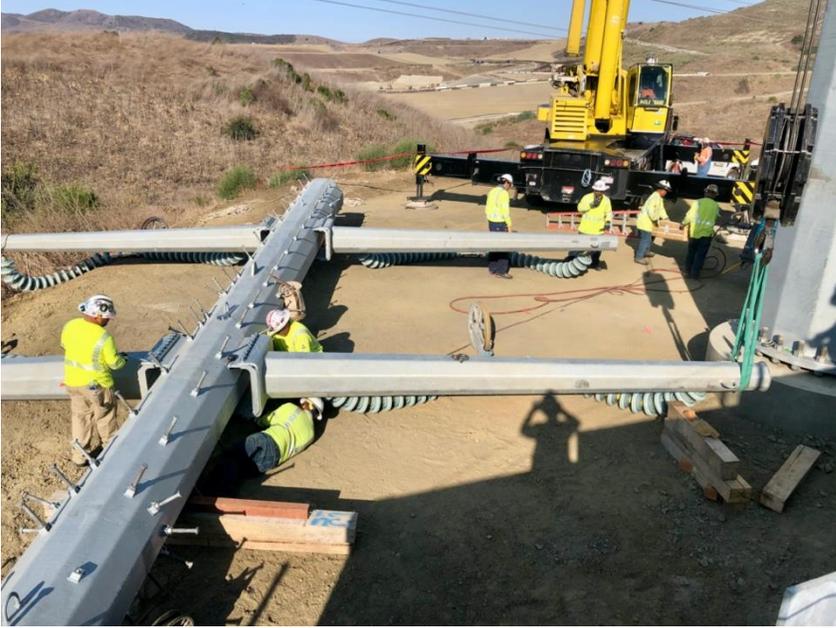
At tower location 24, a crew was preparing the top portion of the TSP for installation (Photo 4). A large crane was set up onsite to lift it onto the lower segments.

Photo 4 – Tower location 24 where a crew was preparing the top portion of the tower for installation. Photo facing west.

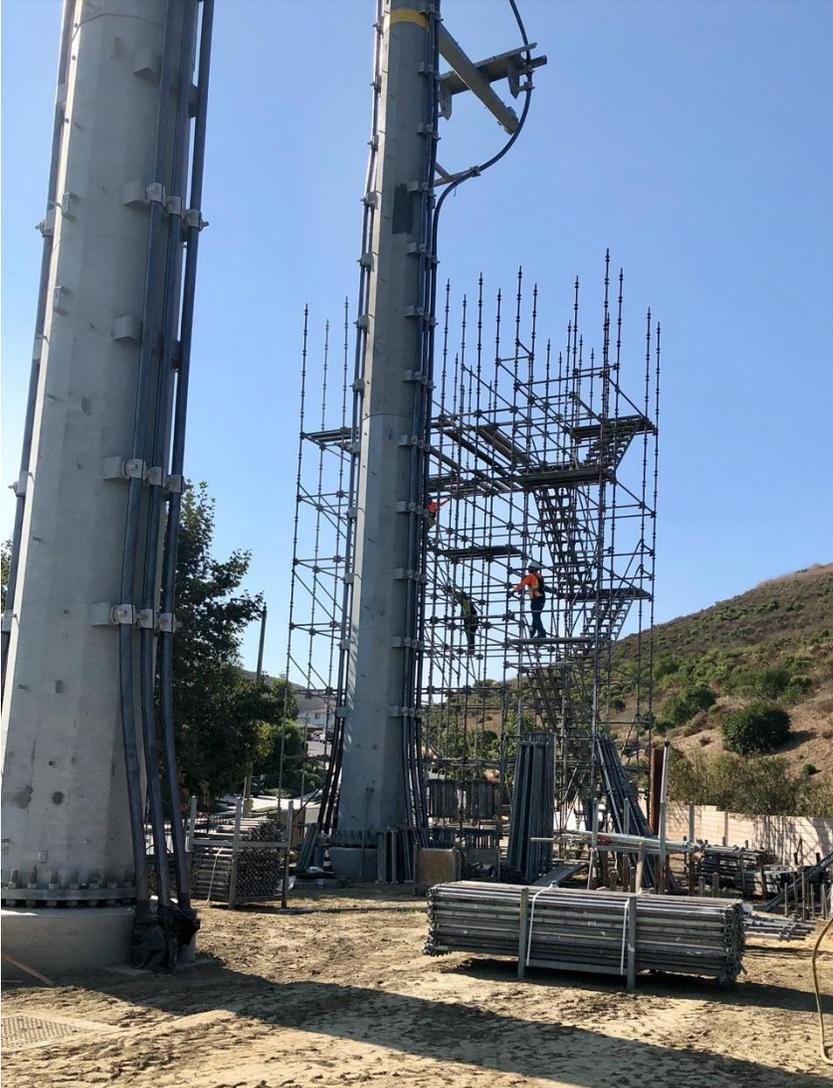
A crew was installing the scaffolding around towers 16 and 17 (Photo 8).

A photograph showing two tall, grey metal transmission towers under construction. The tower on the right is heavily encased in a complex network of steel scaffolding. A worker in an orange safety vest is visible on the scaffolding. The ground is dirt, and there are stacks of metal pipes nearby. The background shows a clear blue sky and a dry, hilly landscape.	Photo 8 – Scaffolding installation at tower locations 16 and 17. Photo facing southwest.
09/24/20	SOCRE transmission corridor

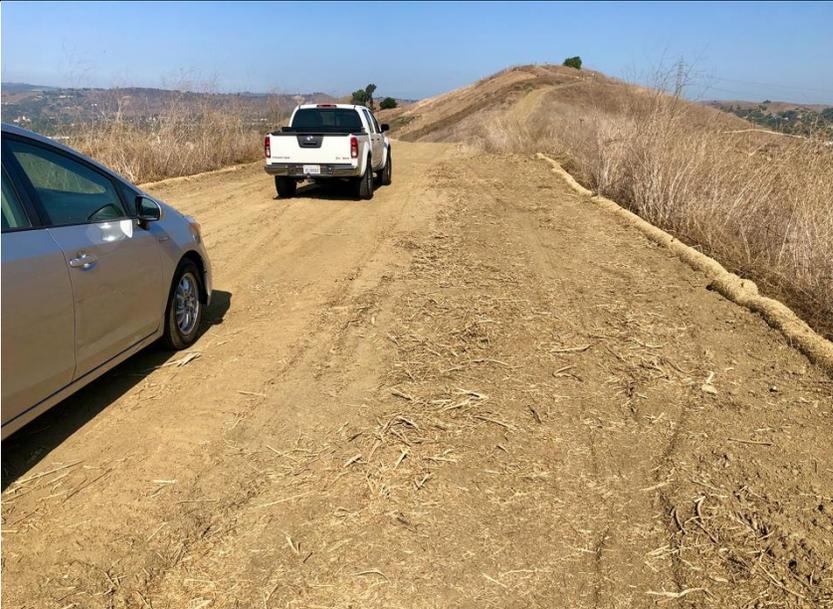
We drove the access road from tower locations 14 and 15 to tower location 13. Along the access road, a small section was widened to accommodate a helicopter landing site (Photo 9). At tower location 13, the foundation was poured and the TSP would be erected that day (Photo 10).

A photograph of a dirt access road winding through a dry, hilly landscape. A white pickup truck is driving away from the camera on the road. A silver car is partially visible on the left side of the frame. The terrain is covered with dry grass and brush, and the sky is clear and blue.	Photo 9 – Access road to tower location 13 widened to accommodate possible helicopter landing. Photo facing north.

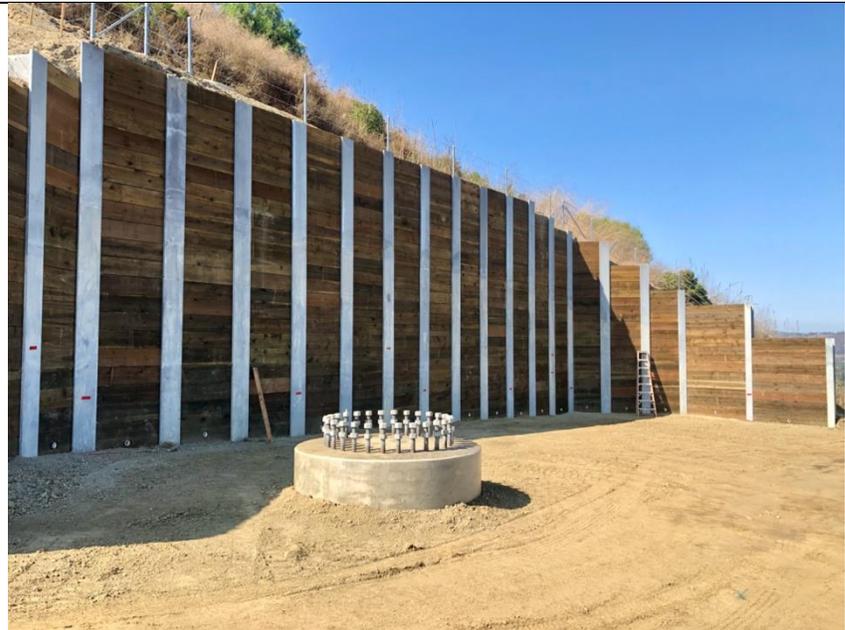
Photo 10 – Tower location 13 where the tower foundation was poured. Photo facing northwest.
09/24/20	West of San Juan Capistrano Substation-jack and bore site

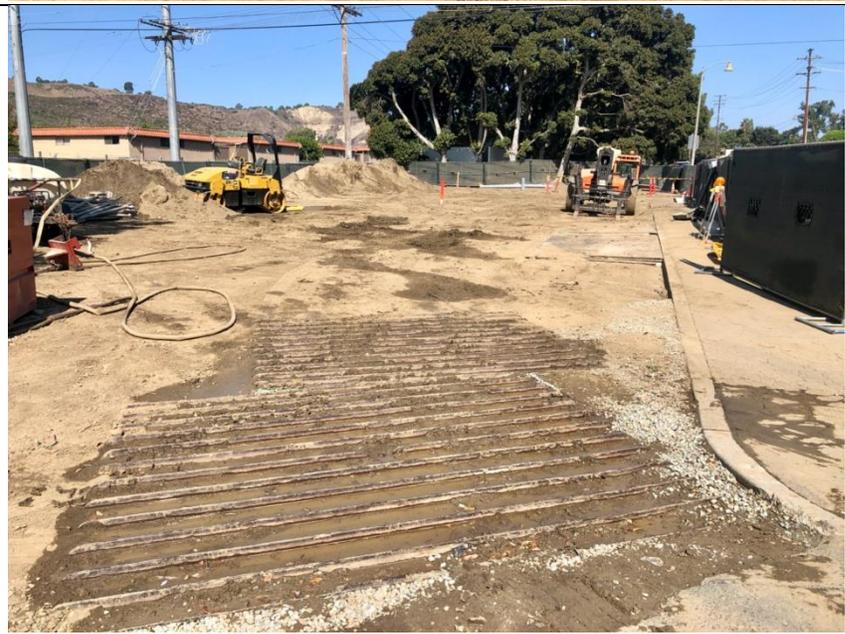
I drove to the substation, stopping first at the jack and bore site along Camino Capistrano (Photo 11). The crew was buttoning up the bore site by completing the final backfilling, and beginning to demobilize. I spoke with the EI about maintaining the exit and entry BMPs to limit mud track-out onto the roadway.

Photo 11 – Bore site restoration. Photo facing north.

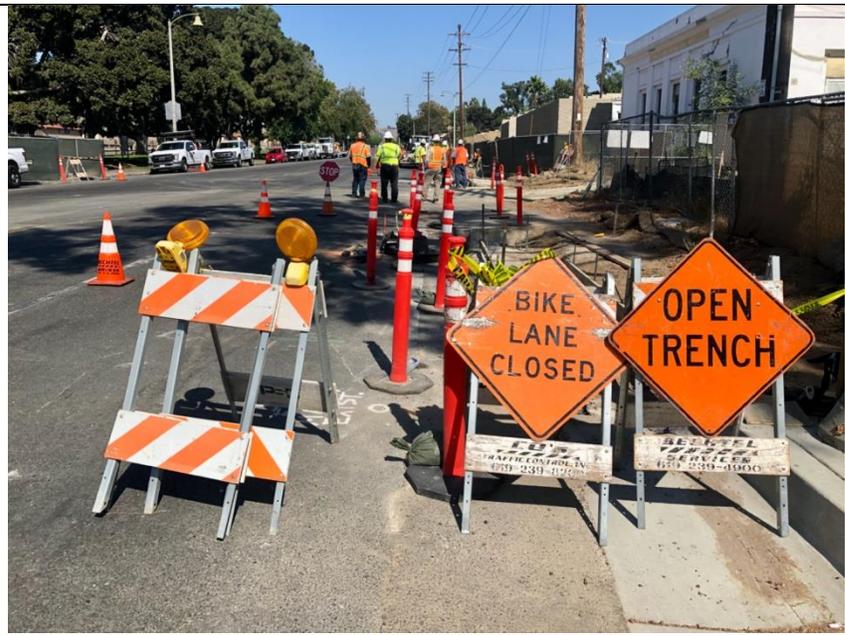
Traffic control was set up within the roadway as a crew was pouring the new curb, gutter, and sidewalk along the east side of Camino Capistrano in front of the substation (Photo 12).

Photo 12 – Traffic control within Camino Capistrano while crews replaced the curb and sidewalk. Photo facing north.
09/24/20	San Juan Capistrano Substation

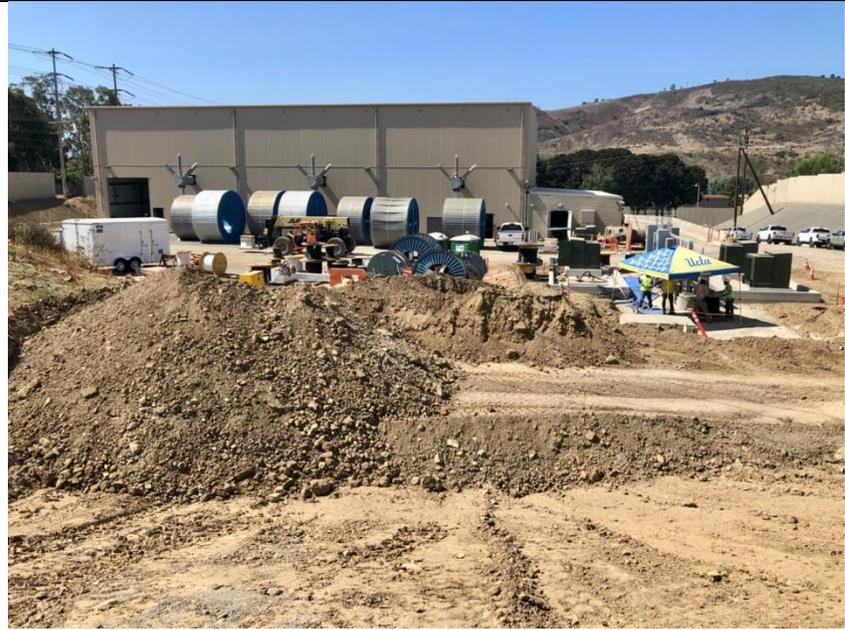
Work within the substation was limited; however, several pieces of equipment had been delivered to the site and staged in the area east of the 138-kilovolt (kV) gas-insulated substation (GIS) building (Photo 13). A crew was pulling wire near the GIS building.

Photo 13 – Several pieces of equipment delivered to the substation were staged near the 138-kV GIS building. Photo facing west.

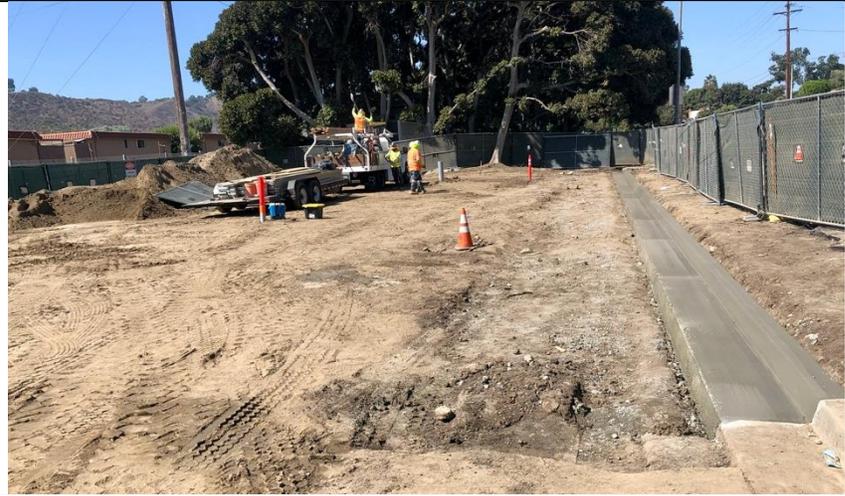
Crews continued to work in the bore pit area west of Camino Capistrano, primarily performing cleanup and demobilization (Photo 1). The exit and entry BMPs required attention and I mentioned this to the EI. The new curb was poured and the new sidewalk was being prepared (Photo 2).

Photo 2 – Cleanup of the bore pit area and pouring of the new street curb. Photo facing north.

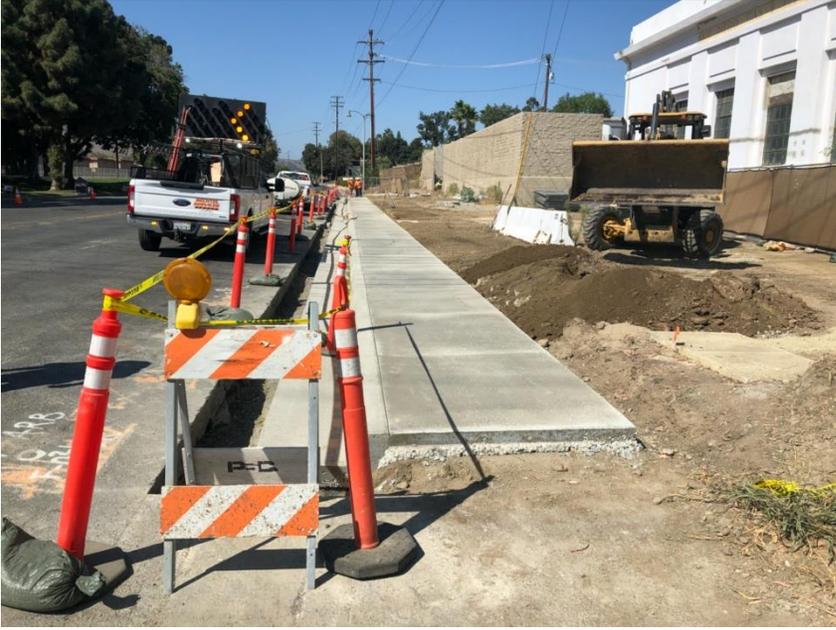
Along the east side of Camino Capistrano, in front of the substation, the new sidewalk was poured and cleanup work was being conducted (Photo 3).

Photo 3 – The new sidewalk was poured outside of the substation. Photo facing north.
09/29/20	San Juan Capistrano Substation

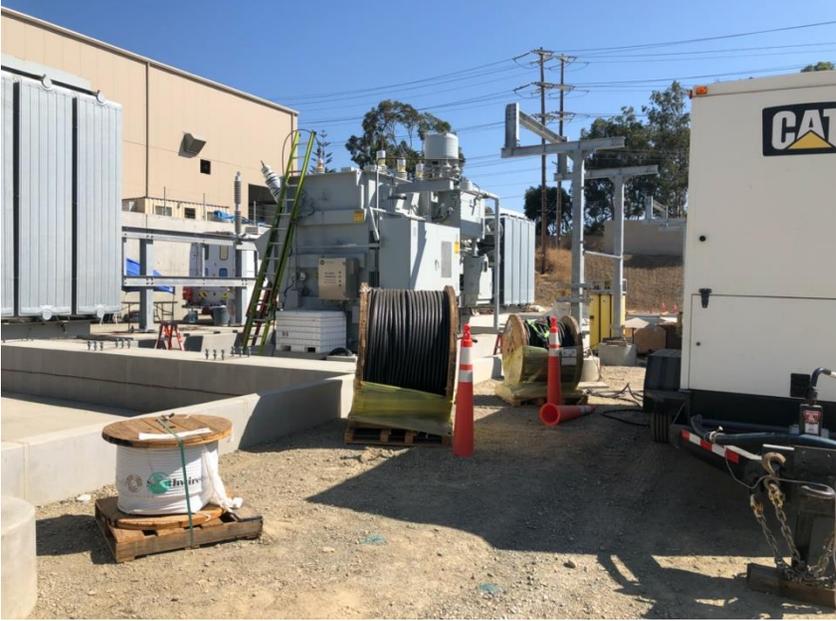
Inside the substation, the EI said work was being performed on one of the transformers that required temporarily draining out the oil (Photo 4). A crew was installing the foundation for the automatic gate at the northern entrance of the site (Photo 5) and wire pulling continued near the 138-kilovolt (kV) gas-insulated substation (GIS) building (Photo 6).

Photo 4 – Work was being conducted draining oil from a new transformer within the substation. Photo facing south.

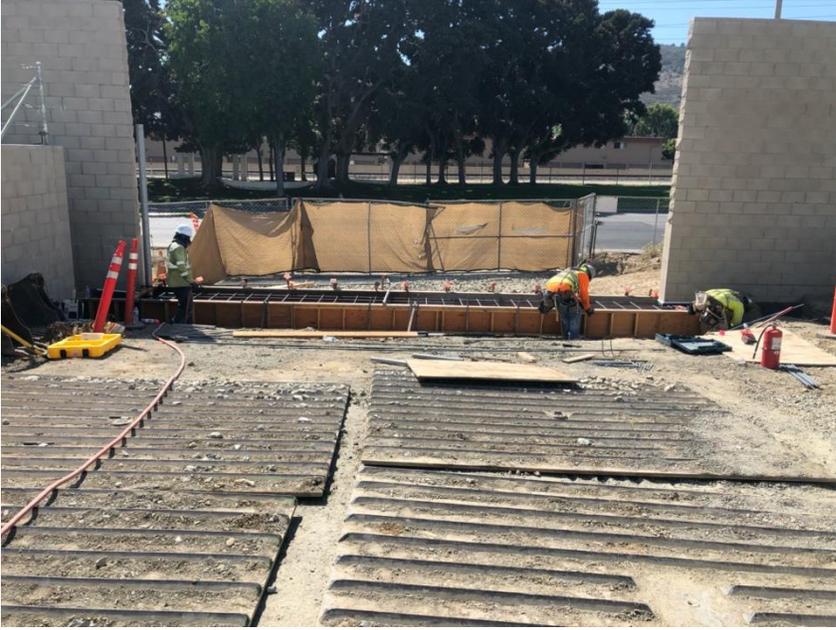
Photo 5 – Foundation work was underway at the northern entrance to the substation. Photo facing west.
09/29/20	San Juan Capistrano Substation

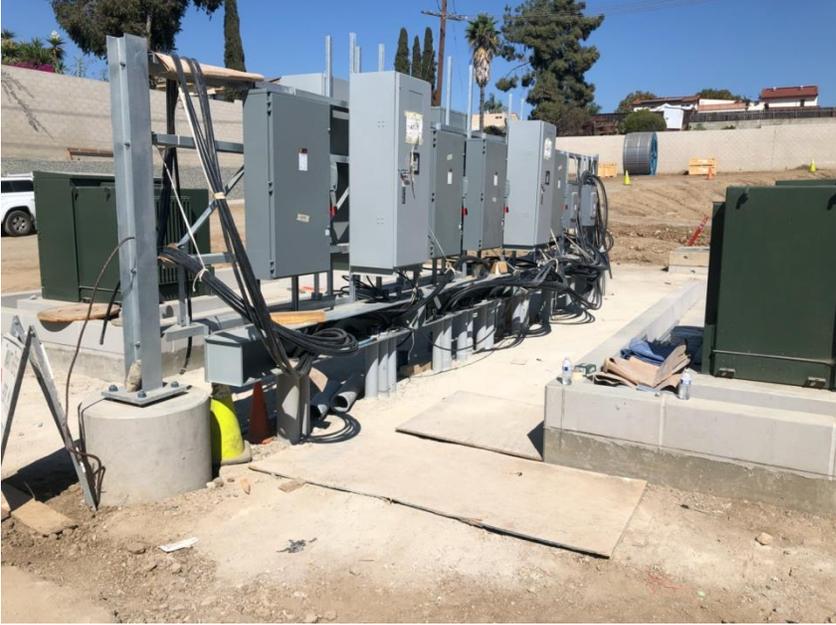
Photo 6 – Wire pulling continued within the substation. Photo facing northeast.

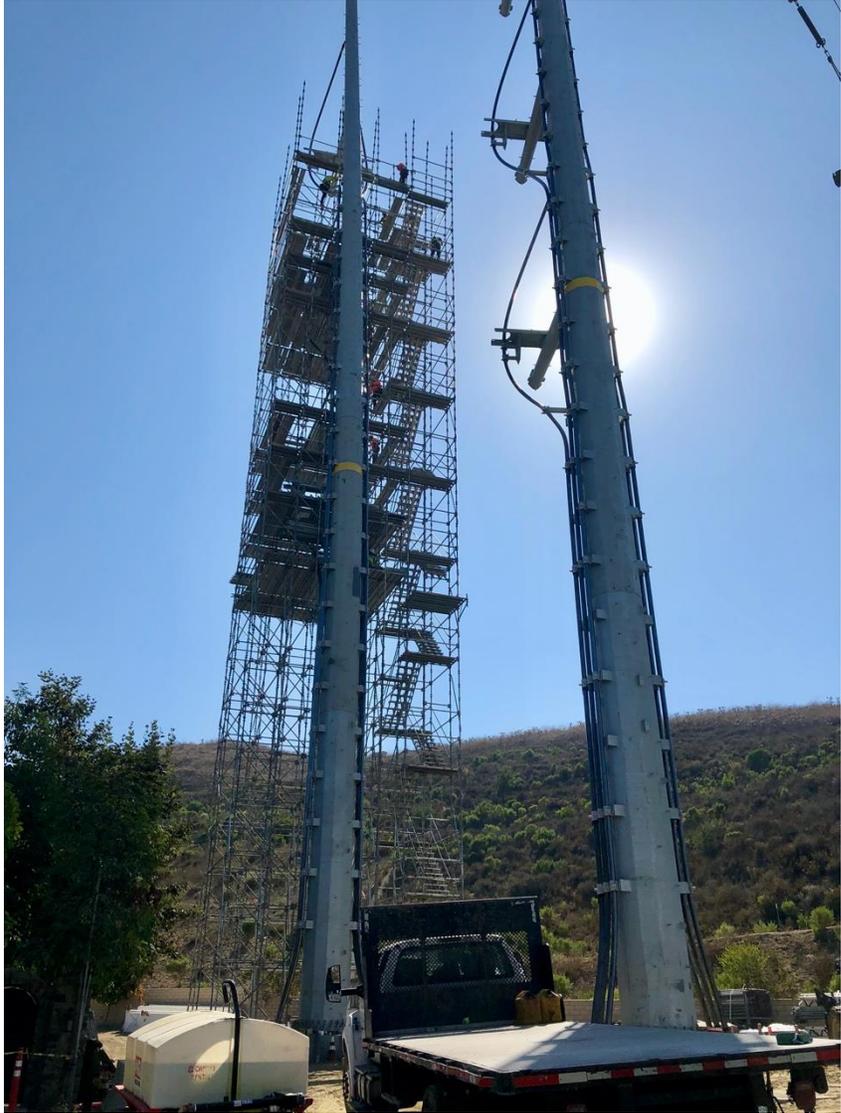
Photo 7 –  
Installation of the  
scaffolding at  
tower locations  
16 and 17. Photo  
facing south.

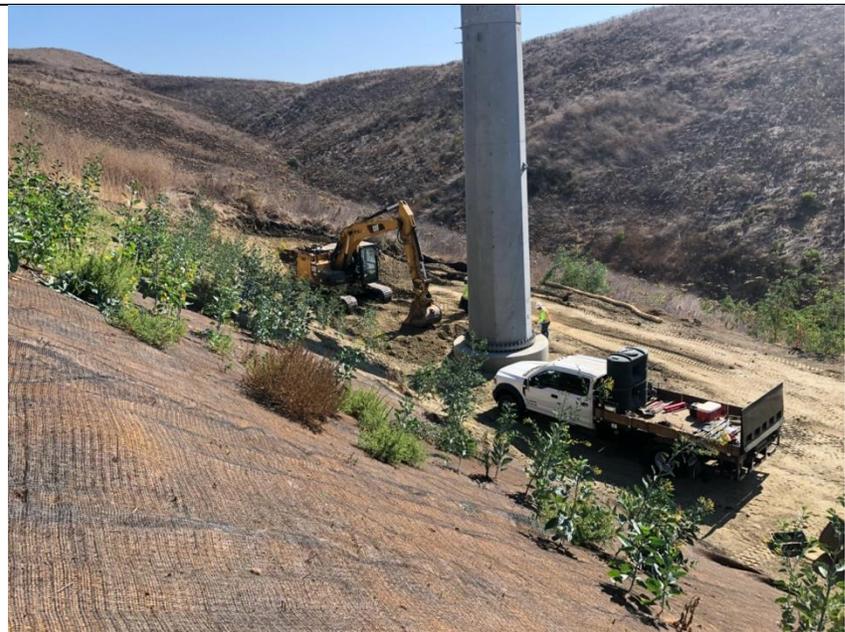
Photo 8 – Excavation for the crane work at tower location 14. Photo facing southwest.
09/29/20	SOCRE transmission corridor

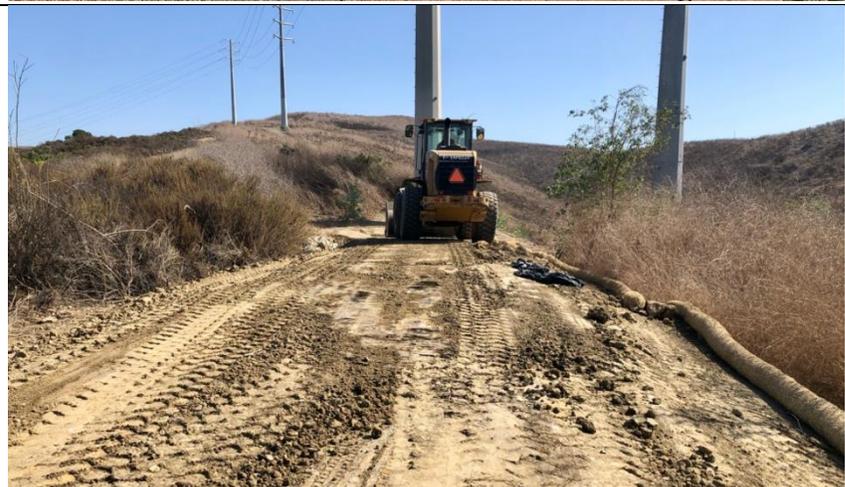
Photo 9 – Soil from excavation at tower location 14 was stockpiled along the access road. Photo facing south.
09/29/20	SOCRE transmission corridor

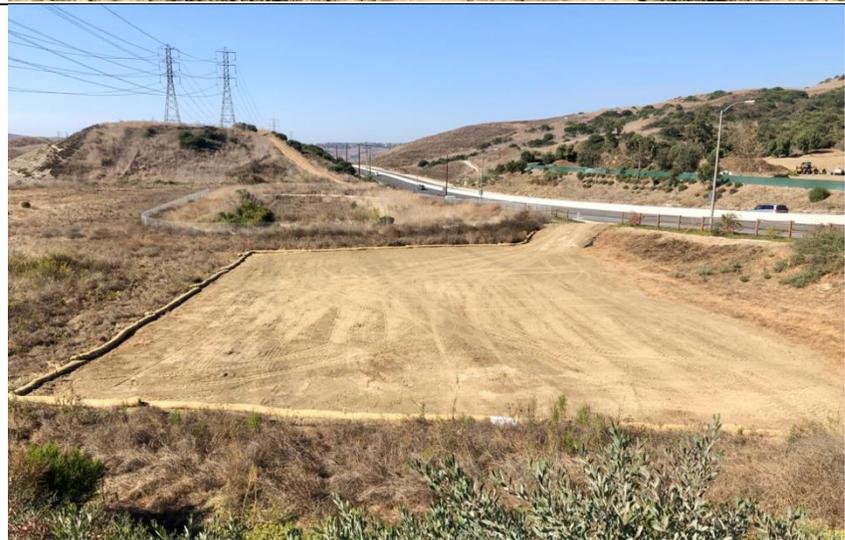
At tower locations 18 and 19, we inspected the helicopter landing area at the intersection of Stallion Ridge Road and Avenida La Pata (Photo 10). The area had been cleared and the access road installed with BMPs placed around the landing pad.

Photo 10 – Helicopter landing pad at the intersection of Stallion Ridge Road and Avenida La Pata. Photo facing northeast.

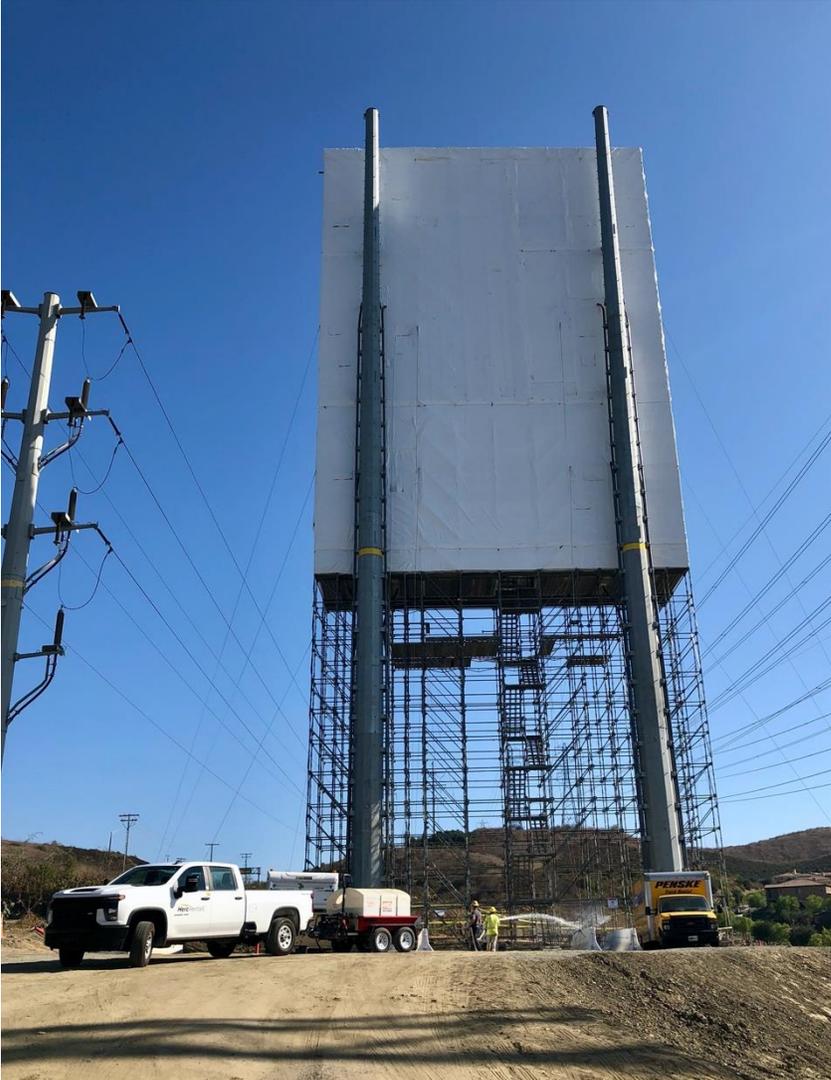
Photo 11 – Tower locations 18 and 19 where dust control was being conducted. Photo facing south.
09/29/20	SOCRE transmission corridor

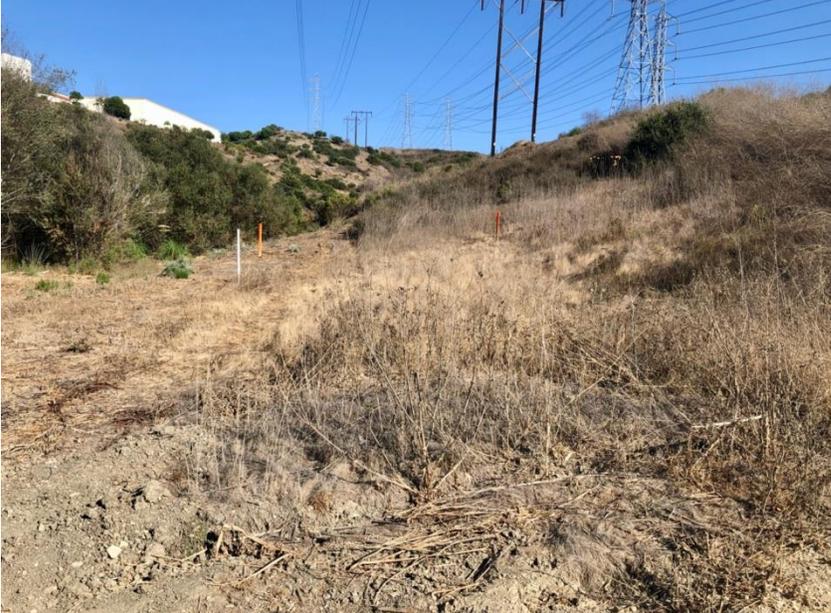
Photo 12 – Possible additional workspace near tower location 39. Photo facing east.

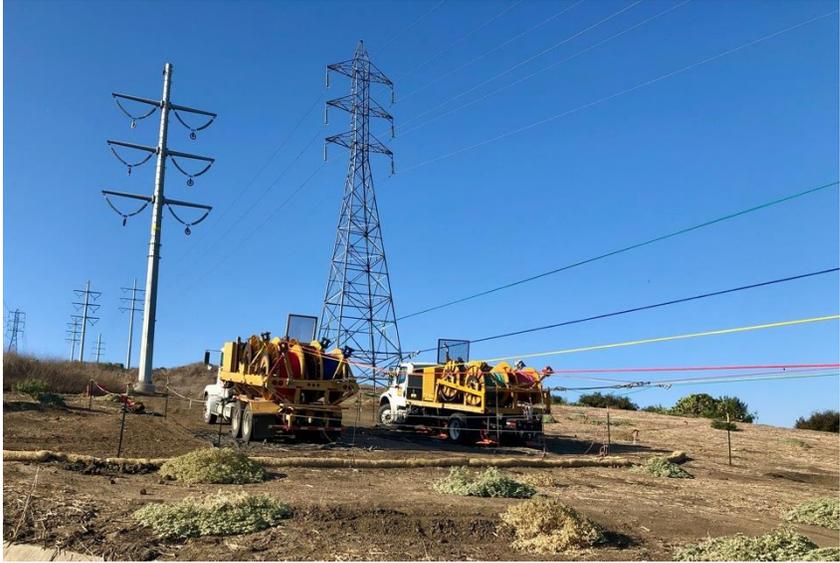
Photo 13 – Wire pulling location near tower location 30. Photo facing north.
